City of San Diego Contracting System Flaws:

Examples of contractor failures causing low quality service and extra cost

July 2008

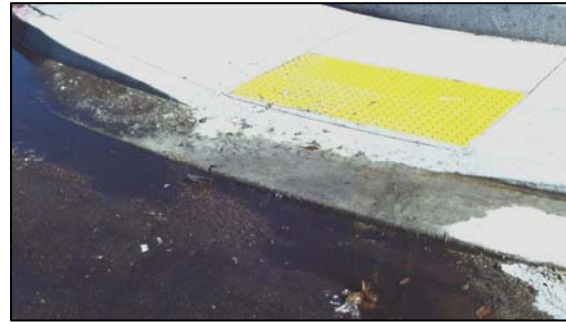
In the residential neighborhood near Mesa College, two of the four pedestrian ramps at the intersection of Armstrong St. and Armstrong Pl. were not correctly connected to the street. Pedestrian ramps most allow a smooth transition from the ramp through the concrete of the gutter to the level of the street asphalt. The contractor failed to finish the portion

between the gutter and the street, leaving a drop-off of one to two inches. This is hazardous for people with limited mobility who rely on walkers, wheelchairs or crutches. The Americans with Disabilities Act design standards specifically state:

“4.7.2 Slope. Transitions from ramps to walks, gutters, or streets shall be flush and free of abrupt changes.”¹

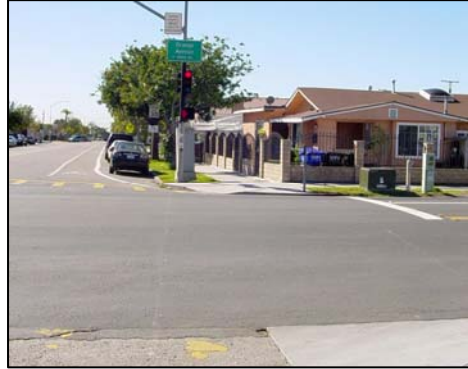
Orange Ave. and 35th St.

Orange Avenue in the Normal Heights area was repaved recently but the crosswalks at the intersection with 35th Street were not replaced. California code recommends that crosswalks be marked and painted yellow when they are within 600 feet of a school or are on the recommended route for students to approach the school. This intersection is 100 feet from Edison Elementary School.

*"Whenever a marked pedestrian crosswalk has been established in a roadway contiguous to a school building or the grounds thereof, it shall be painted or marked in yellow as shall be all the marked pedestrian crosswalks at an intersection in case any one of the crosswalks is required to be marked in yellow."*³

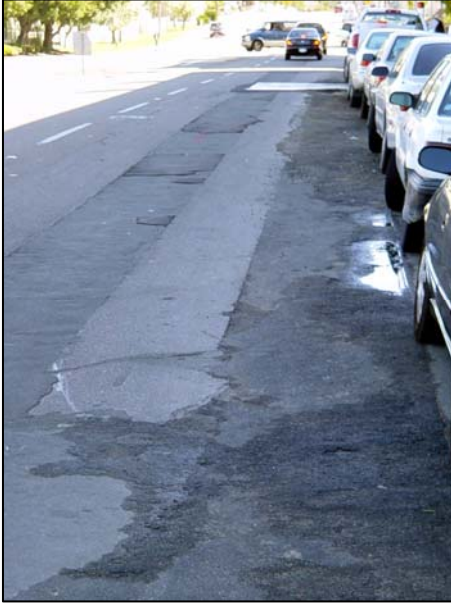
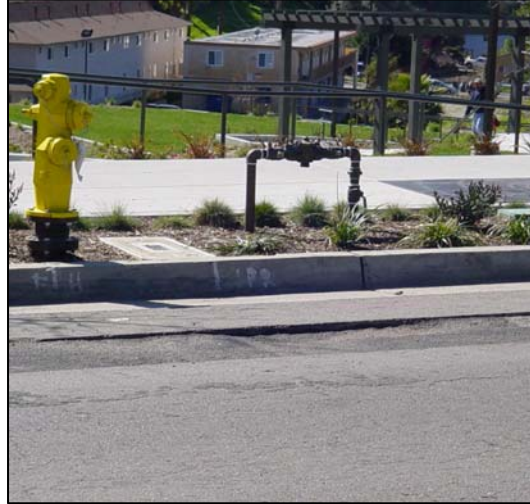
Contractors for a new housing development at University Avenue and 52nd Street have continuously reopened and temporarily patched street trenching over a 4-month period. Poor trenching and repair leave uneven driving surfaces, potholes and sharp drop-offs which can lead to vehicle damage such as cracked wheel rims or popped tires.

Poor trench repair at University Ave. and 52nd St.

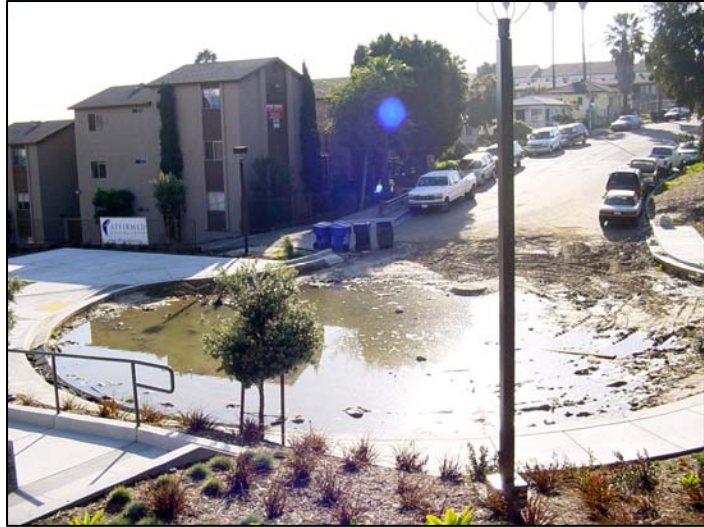
*Old University Ave.
near 50th Street.*

A new cul-de-sac meant to improve the end of old University Avenue where it intersects with a new development has not been finished, remaining unpaved, filled with trash and during the rains, filled with water.

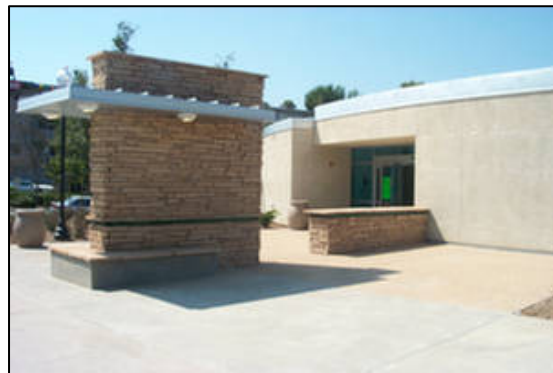
The newly constructed College Heights/Rolando Branch Library has a welcoming entrance with bench seating and lighting with decorative flagstones, installed by a contractor. Shortly after the grand opening, flagstones were coming loose and falling out. City workers glued them back into place.
